DRR-Team Mission Report

Mozambique – Licungo Basin

15 June 2015

15 June 2015
DRR-Team Scoping Mission, Final Report
Flood Control in the Licungo Basin of Zambezi Province

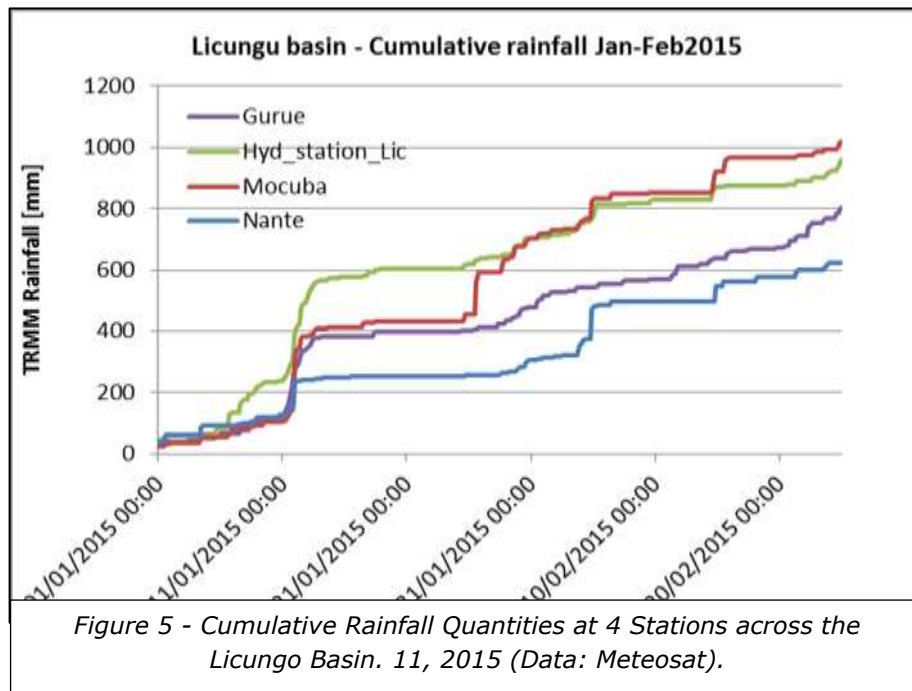
Figure 5 - Cumulative Rainfall Quantities at 4 Stations across the Licungo Basin. 11, 2015 (Data: Meteosat).

Based on Meteosat/TRMM data it can be deduced that between 11-13 January the entire Licungo River Basin received a rainfall quantity of about 300mm in 3 days, see Figure 5.

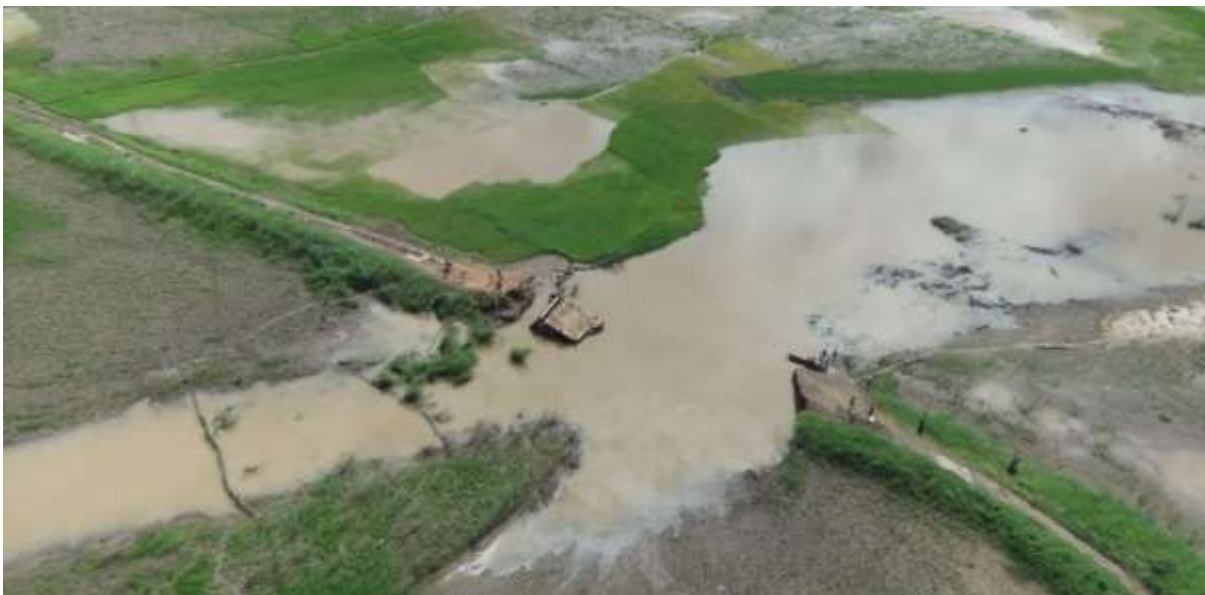
Figure 13 – Collapsed Bridge and Breach at Naminane

Because of the breach and the collapsed bridge the connection of the road was closed. The distance covered by the team was 2 kilometres up to this breach. The team could not cross the breach (is a lake) by canoe because of government safety restrictions applicable to the DRR-Team members.

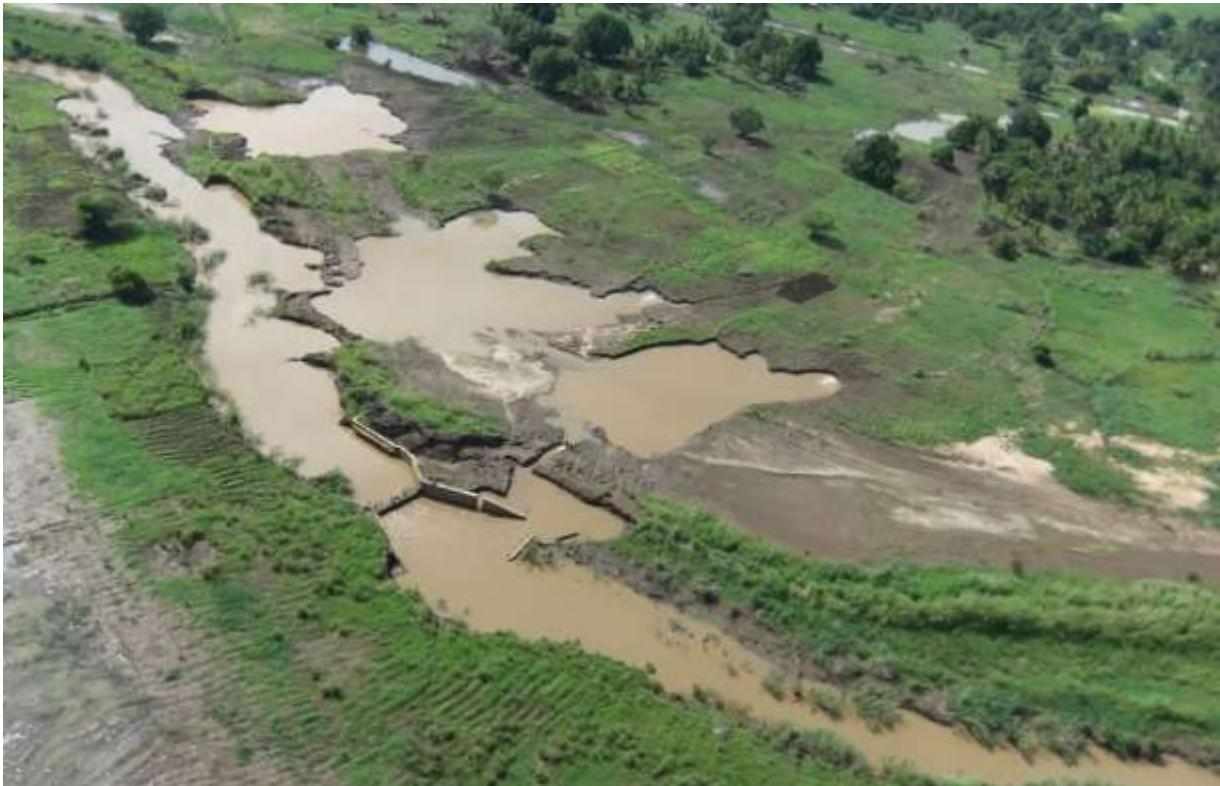
Figure 15 – Eribacila Weir in the Cune River

the weir have wing walls downstream and upstream of the barrier. The weir and surrounding were totally submerged by the floods of 2015. This place was not visited by the DRR-Team because of difficult access conditions.

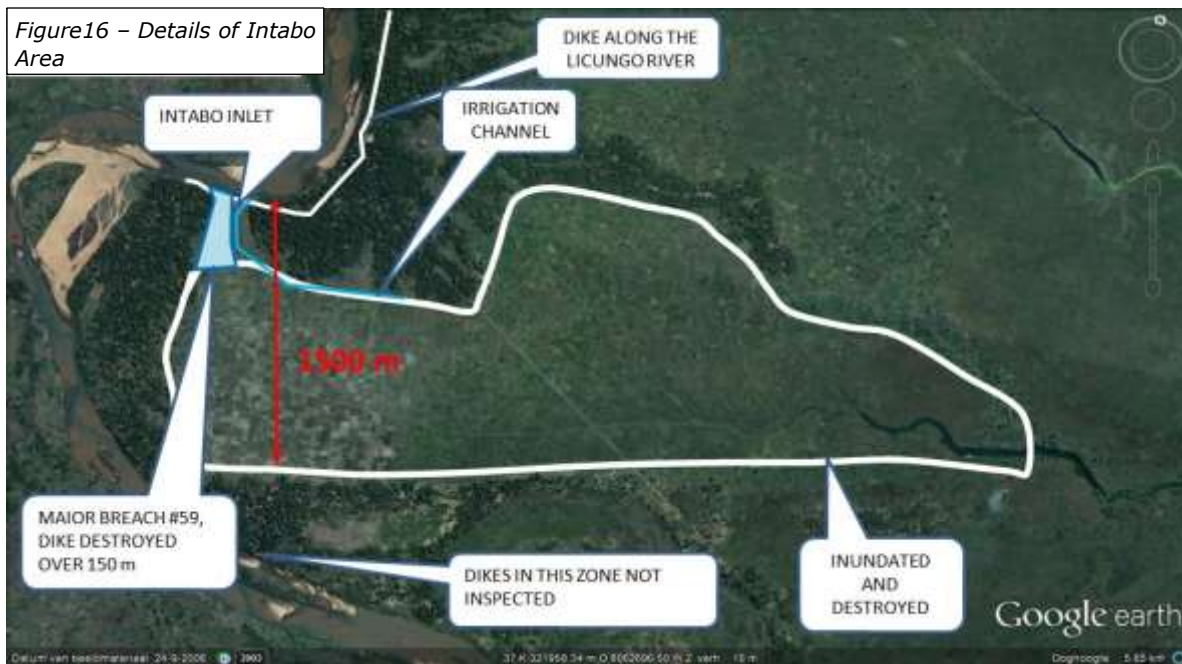
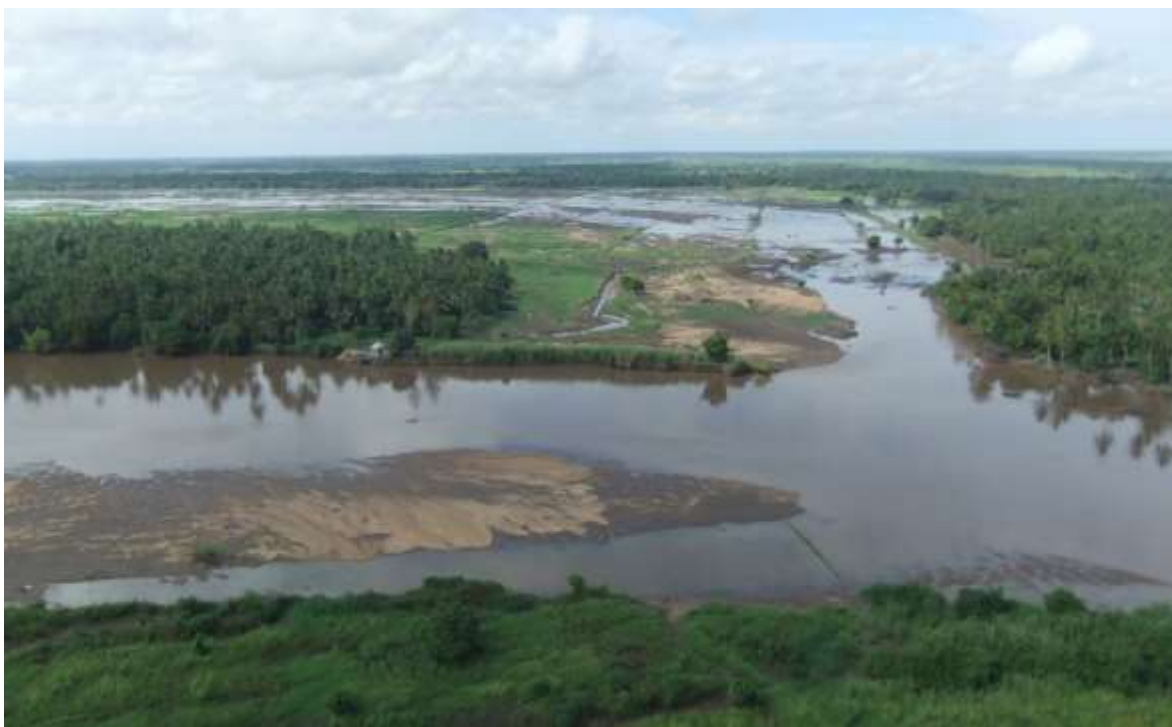
Figure 17 – Intabo Intake Station, Canal and Breach

The Intabo intake structure, see Figure 16, serves a vast irrigation scheme. The structure is located in the outside curve of the Licungo River, where the current of the flood waters has a heavy impact on that left bank representing a high risk of erosion. This led to the rupture of the downstream dike over at least 150 meters (Item 60 of cost estimate) and a big influx of water (actually a "new" river) into the irrigation scheme behind the dike, see Figure 17. As the new river blocked the access to the rest of the dike the DRR-Team was forced to stop here and return to Nante. The soil necessary for the restoration of the dike is not locally available and has to be taken from a place close to the semi-circular loop not far from Nante, distance about 6.5 Km. Topographic surveys should be executed in all areas so as to know the dike, structures and field levels.

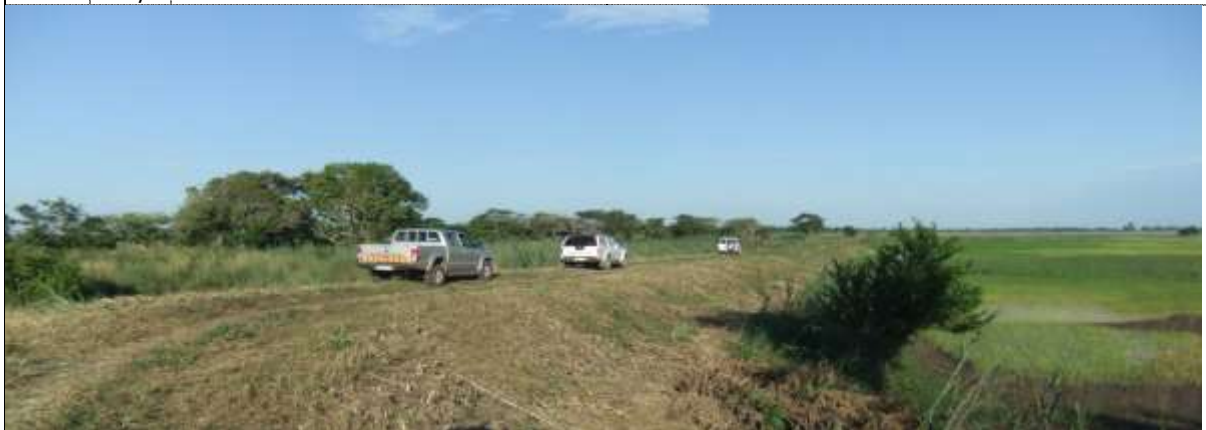
#	DATE	LOCATION	#	DATE	LOCATION
	15/4	Naminane Dike

View from the start of the semi-circular dike. This part of the dike is lower and has been overtopped by 1.80m of water. The sediment right side of dike was deposited by the floods.

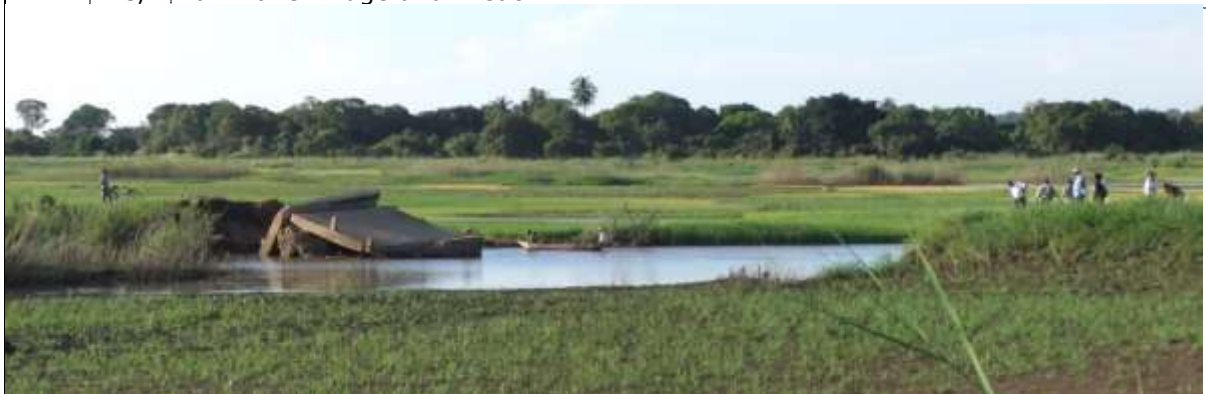
1+2	15/4	Naminane Bridge and Breach
-----	------	----------------------------

The concrete bridge was broken and inhabitants cross the breach by canoe

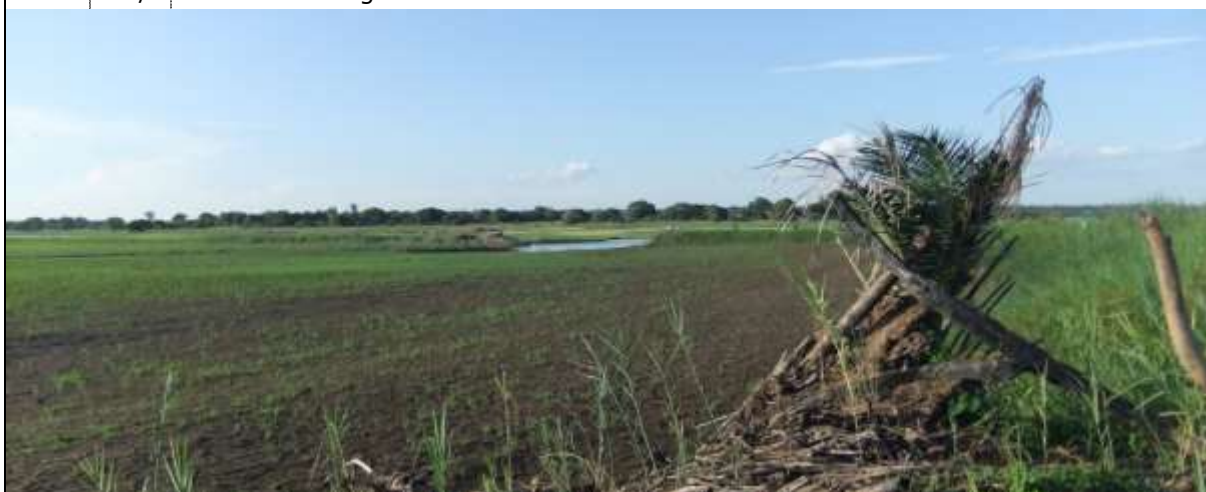
1+2	15/4	Naminane Bridge and Breach
-----	------	----------------------------

The grasses and debris in the palmtree show the level of the flood. The brown soil was freshly deposited by the 2015 flood.

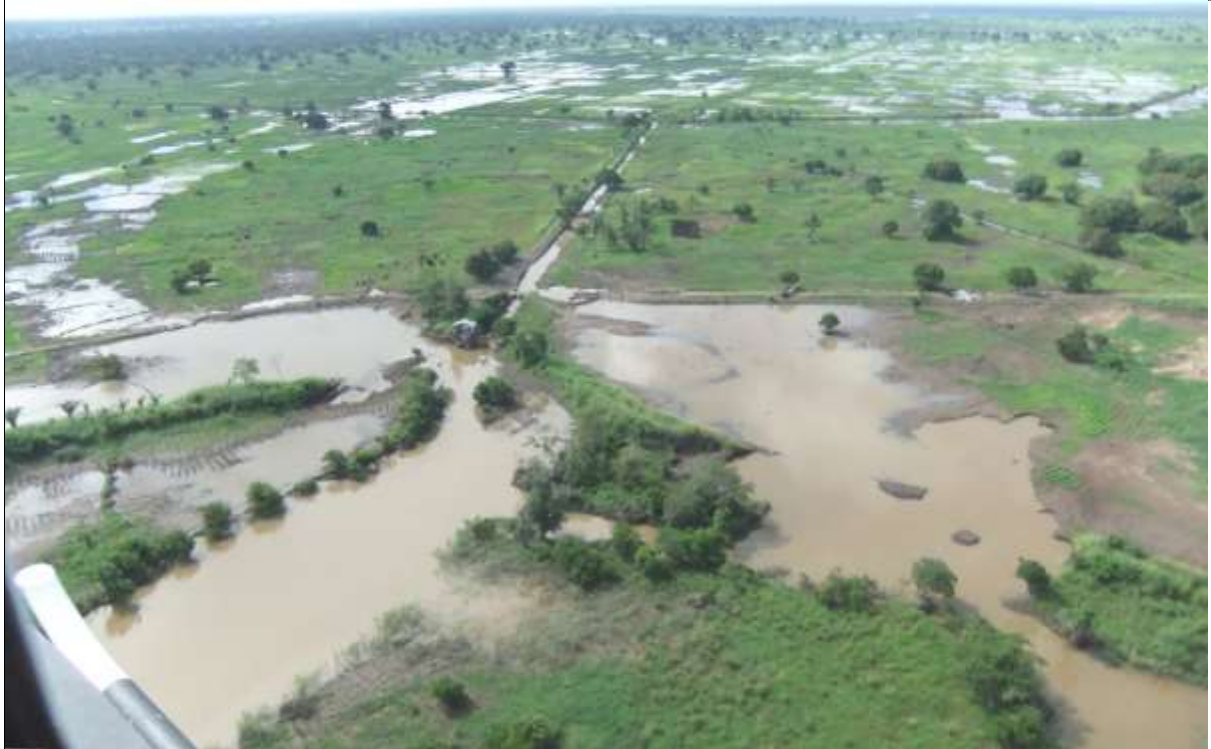
Munda Munda					
-------------	--	--	--	--	--

The intake station of Munda Munda is situated in the center of this aerial view. The road crosses the picture from far right to far left in the middle of the photo. The intake canal and the irrigation scheme are visible in the back ground. The intake section of the river is shown in the left-bottom corner. The continuation to the right (down stream) of the dike stretches from the station to the the right-bottom corner of the picture and is severely damaged. This dike continues to Eribacila weir complex.

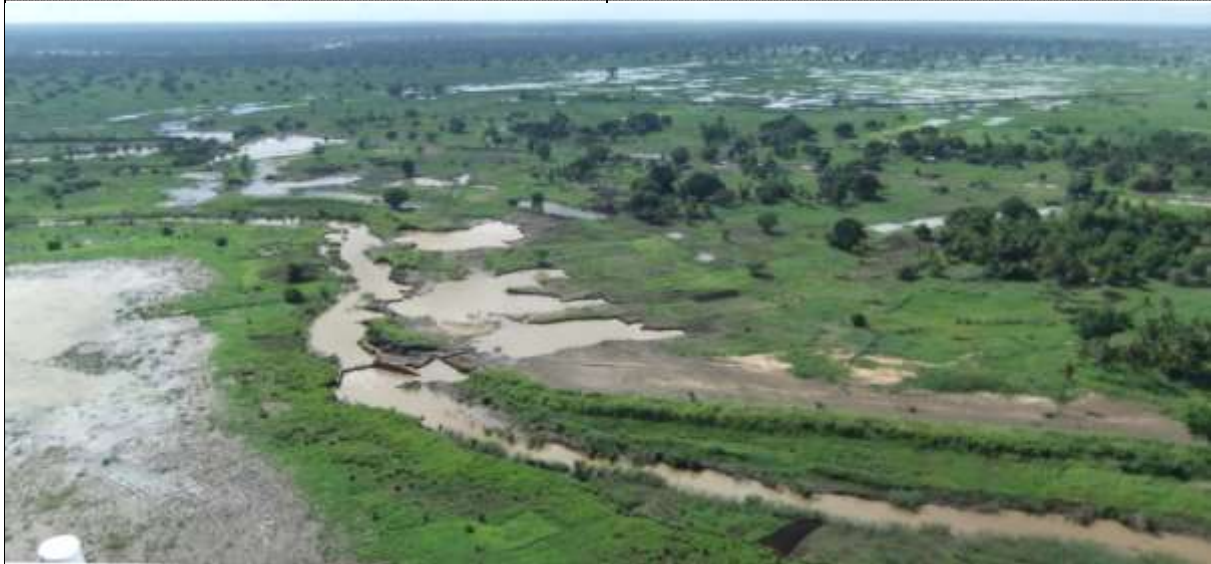
31-32 16-4 Eribacila weir complex.

The weir is heavily damaged. In the back ground, left, the intake canal and the irrigation scheme are visible.

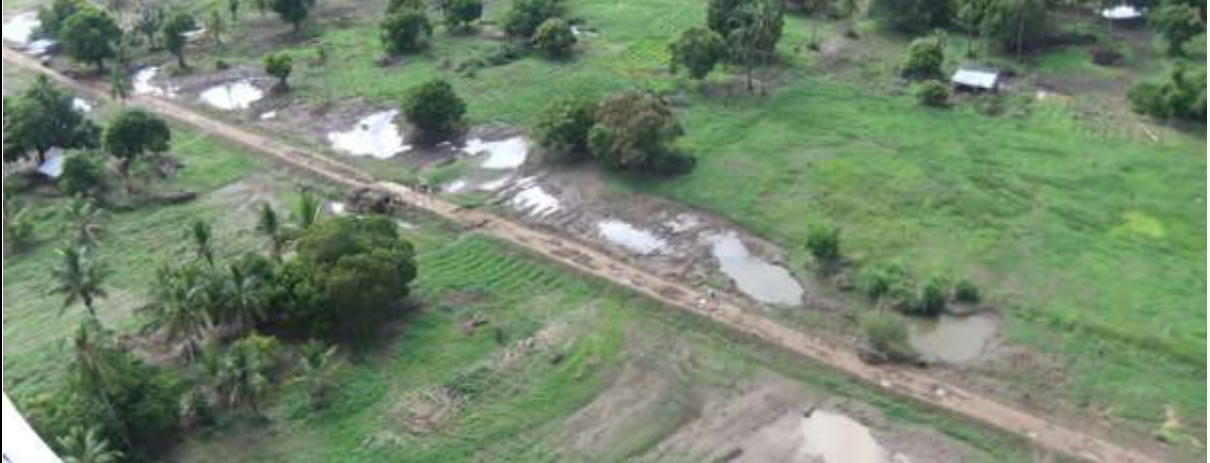
Road between Munda Munda and Muguloma

The top of the road is damaged by over flowing water over a length of 5000 m (Estimated) and will need repair so as to allow for passage of cars.

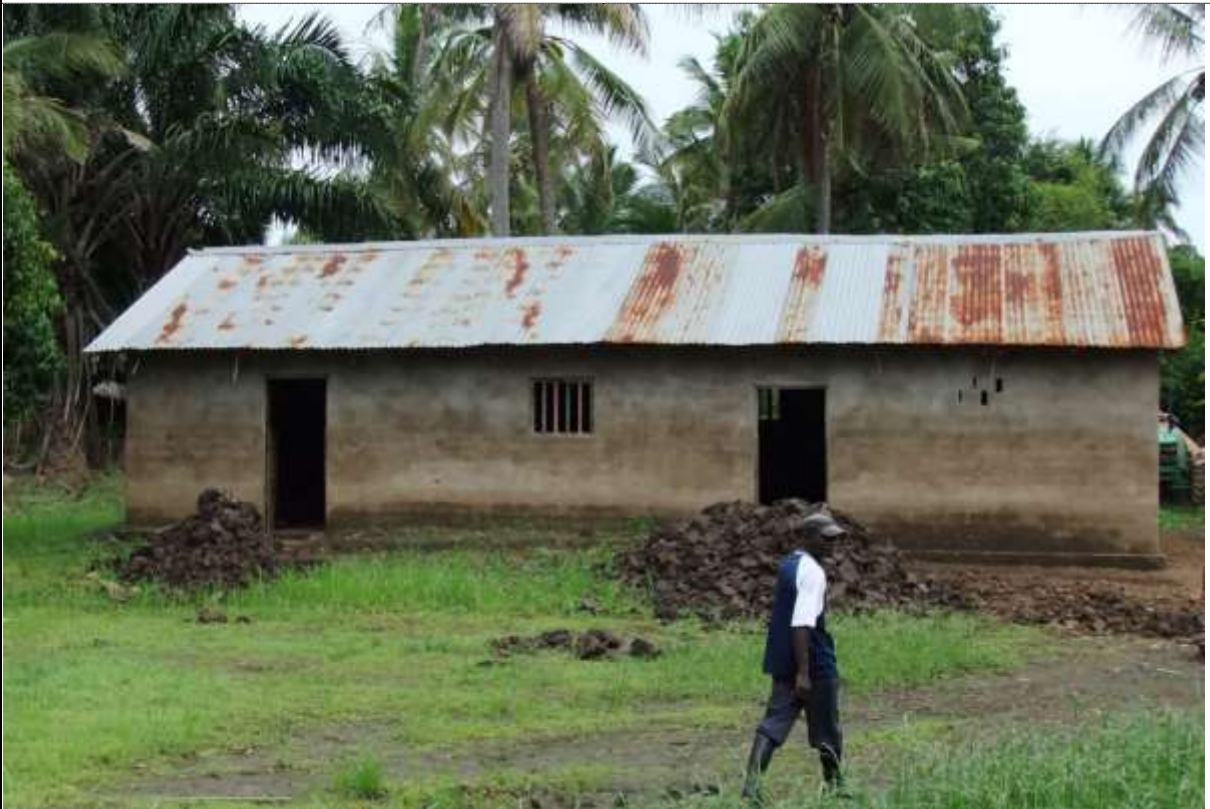
The house of the Fumo (Local authority)

shows the latest water line at the down side of the window.

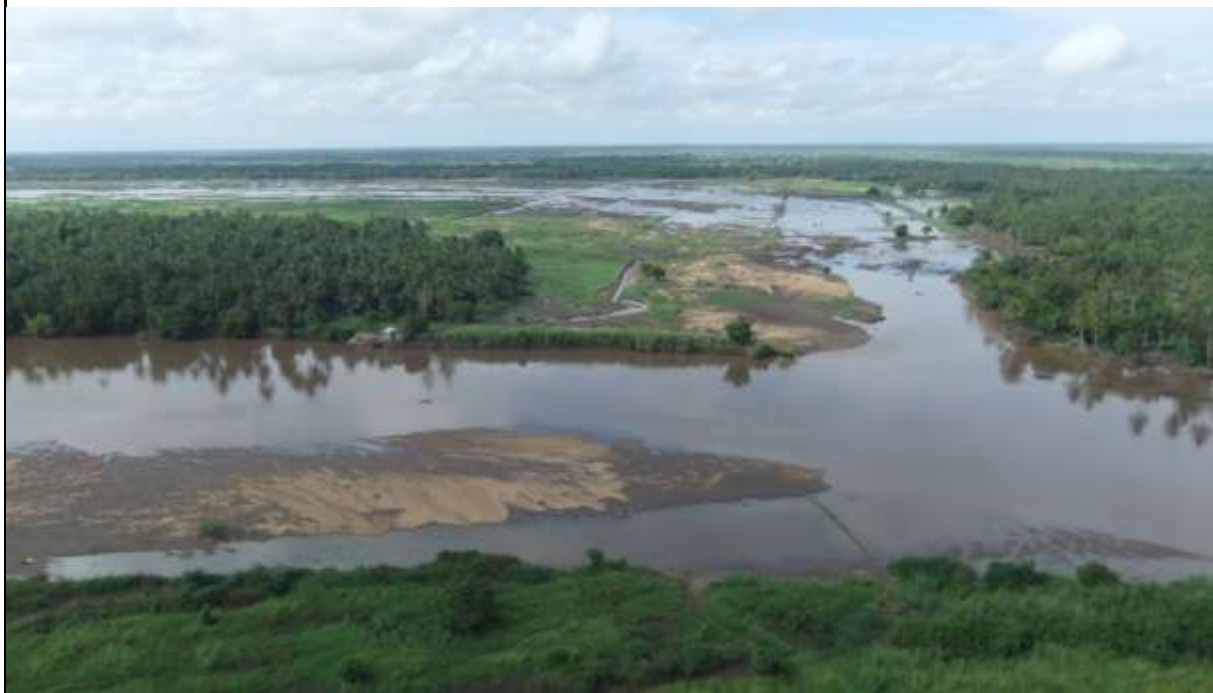
60	16-4	Intabo intake station
----	------	-----------------------

The intake station and the canal are visible at the edge of the trees. The river that diverts to the left was created by the flood and inundated vast areas inland. The dike is broken over some 150 meters. The agricultural experts raised the question whether the dike should be re-installed or that an other solution is to be designed.

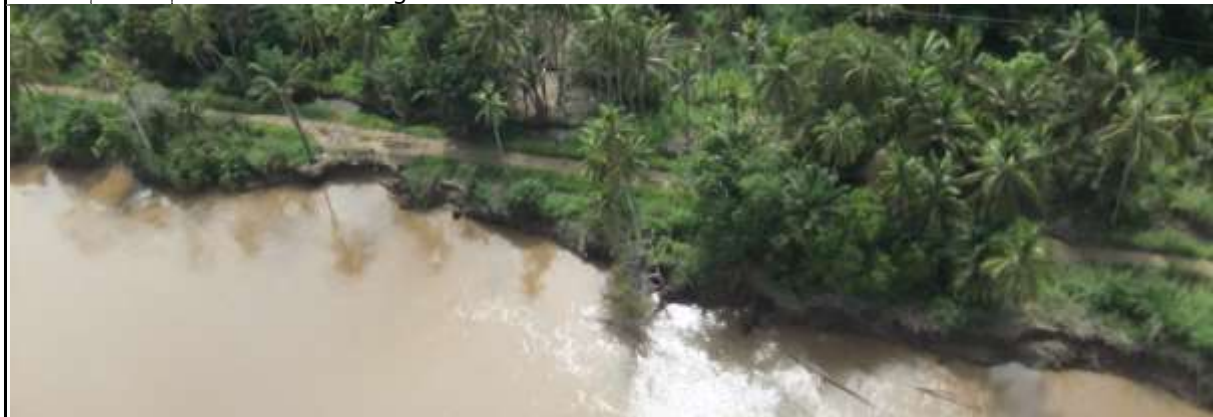
53-57	16-04	River berm of Muguloma
-------	-------	------------------------

Before arriving at Intabo the road borders the river very closely. In many places the berm has been eroded by the water, probably not only by the last flood of 2015. The houses of the inhabitants of the zone lay behind the road. In order to safeguard the road action should be taken to protect the berm. The installation of Gabions may give a mid-term solution. In case the road is to serve more traffic in future more permanent works may be necessary.

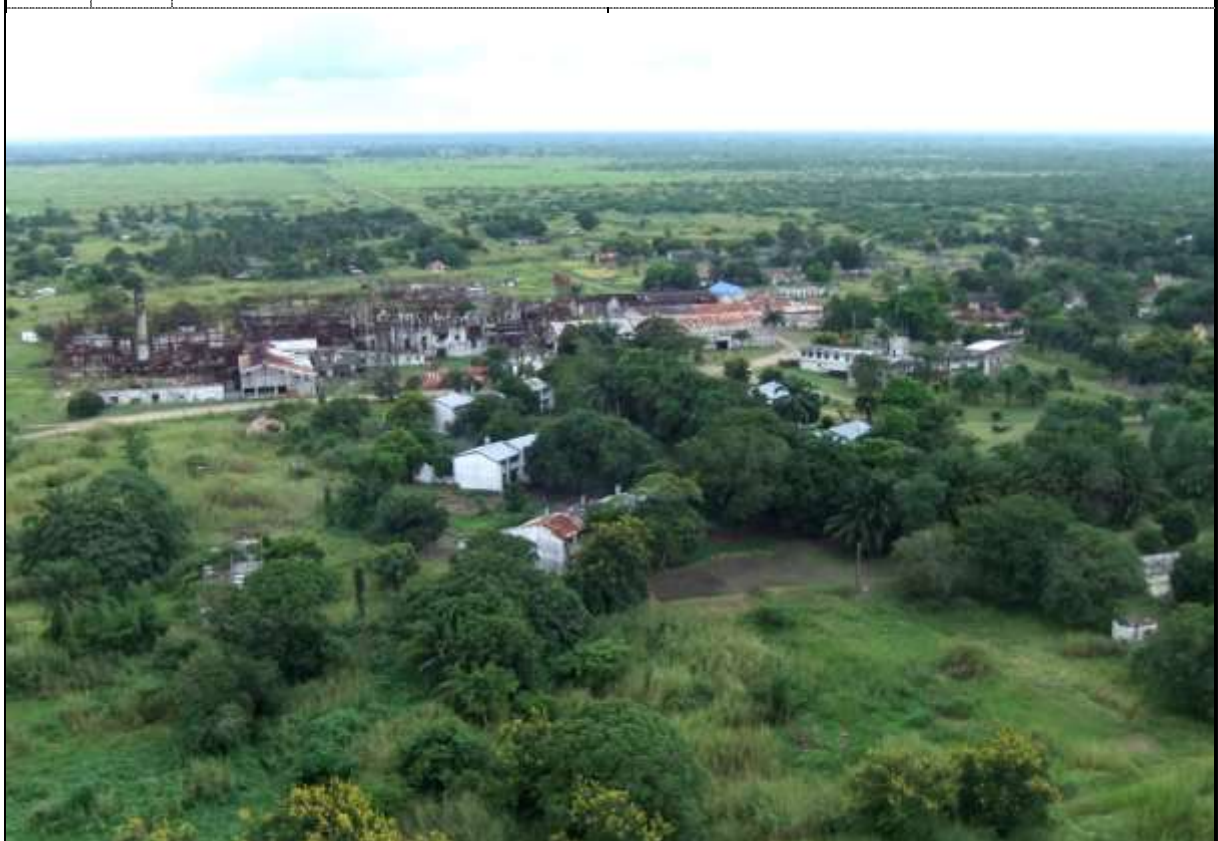
17-4	Town of Luabo
------	---------------

The town of Luabo seems abandoned. Fields in the surrounding do not seem to be used. No major breaches were seen in the dikes during the flight. Detailed surveys on the ground may show hidden damages, also originating from earlier floods.

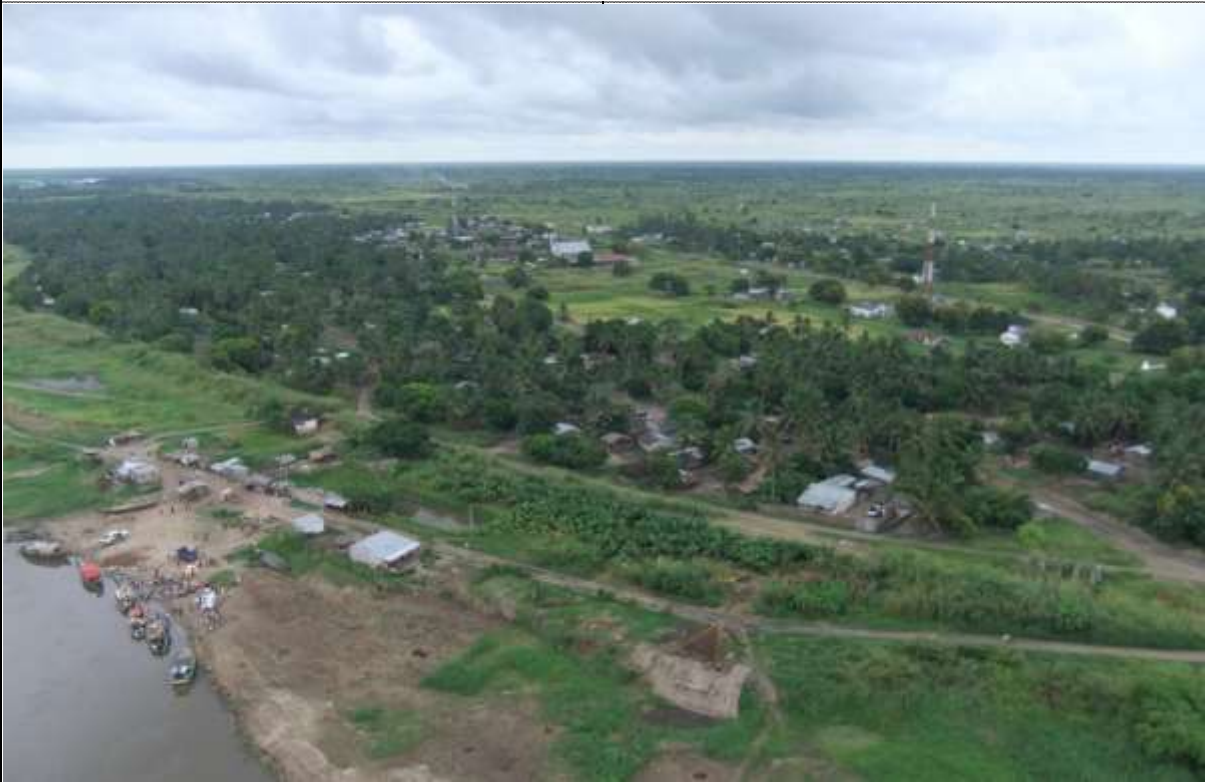
17-4 Town of Mopeia

The dikes visible on this picture seem to be intact and heavily overgrown by greens. On several parts crops are grown on the sides of the dike. This practice should be forbidden as it degrades the quality and the level of the dikes..

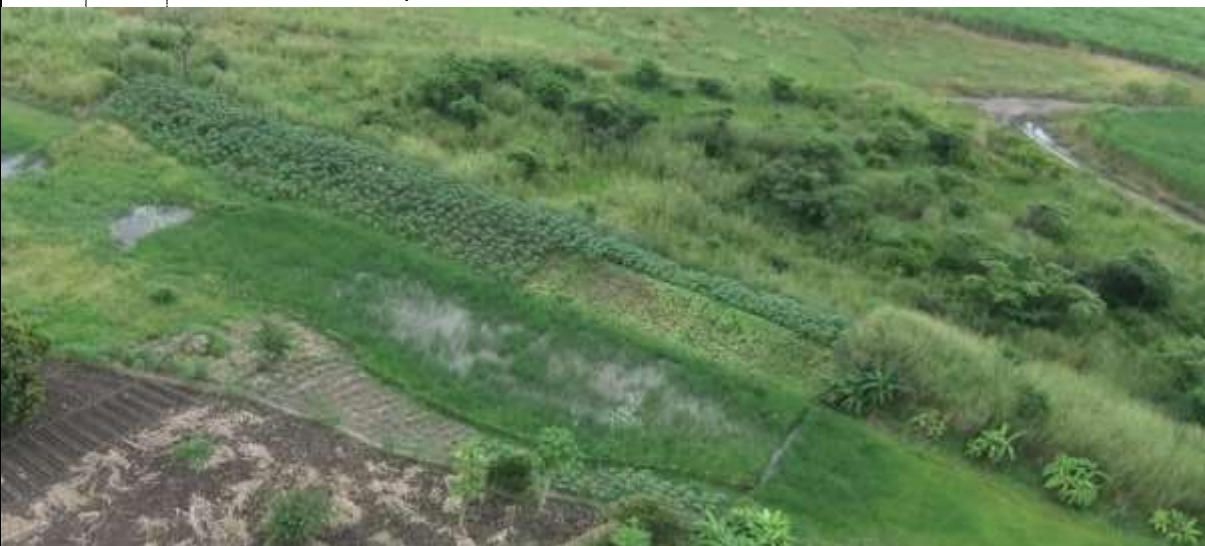
17-4 Dikes in the vicinity of Marromeu

The dikes in the surroundings of Marromeu do not shown major breaches. In general the dikes are overgrown with greens, mainly elephant grass. On several places agriculture is being practiced. This should be forbidden as it degrades the quality and the level of the dikes.

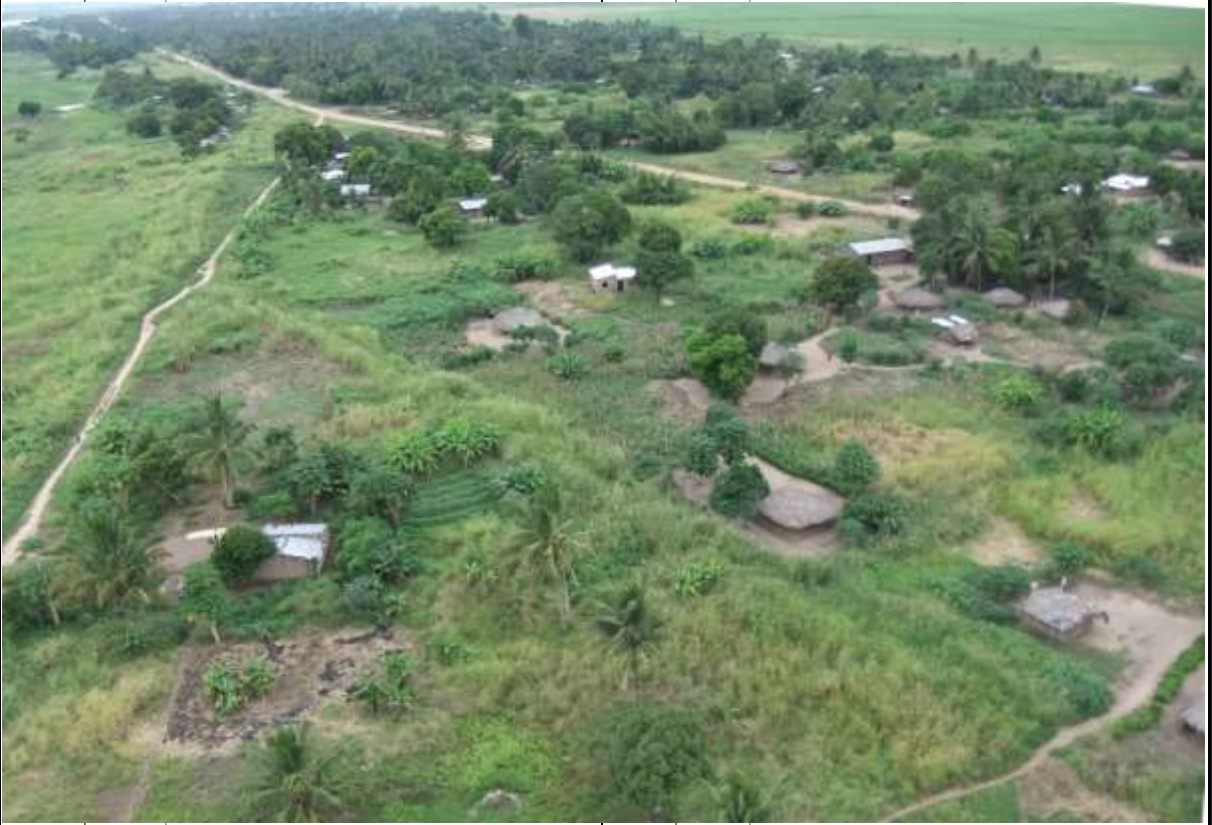
#	DATE	LOCATION
17/4	17-4	Surrounding of Marromeu

The dikes visible in this picture do not show major flood damage and seem to be over grown with grasses for several years.

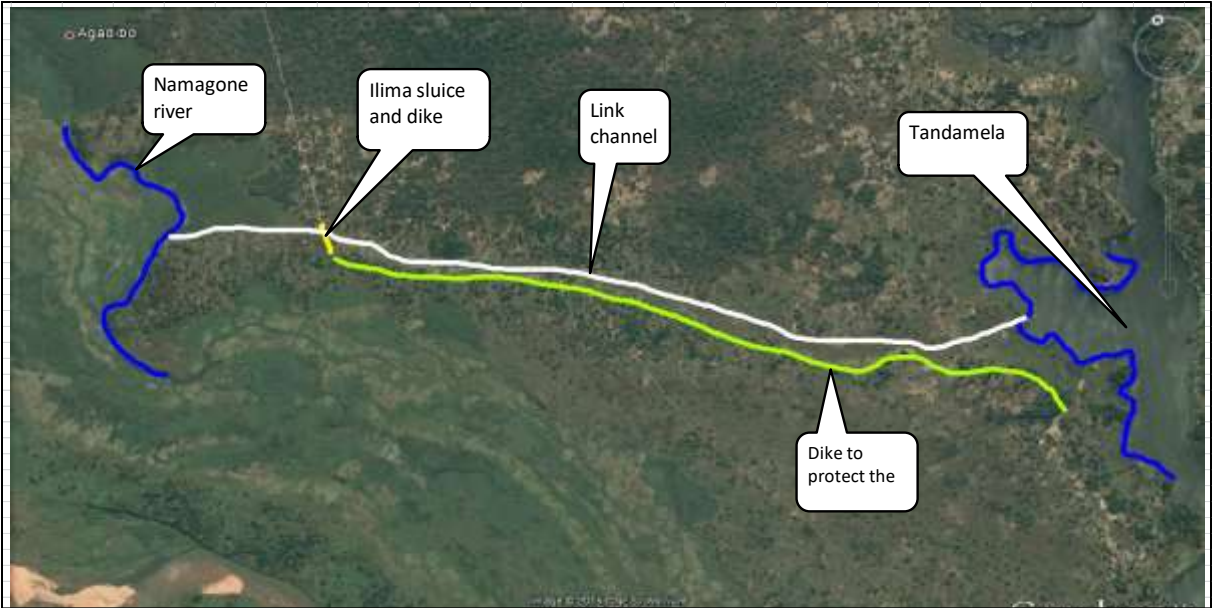
Figure 22 The Future Sluice Complex with Link Channel

As in the other parts of this report was stated; the recent floods in the river basin of the Licungo river were exceptional. That is why certain parts of the Munda Munda irrigation project must be adapted to this new situation; specially the dikes and river works. In this paragraph we will discuss some critical issues and places where adaption is needed. First of all the situation at free intake at the bifurcation of the Namagone River. It was clear, already before the January 2015 floods that this structure must be built in such a way that it can be inundated without being destroyed during the passage of the floods. The second critical point is the situation near Ilima. Figure 22 shows the future sluice complex with the link channel in a *google earth* map.

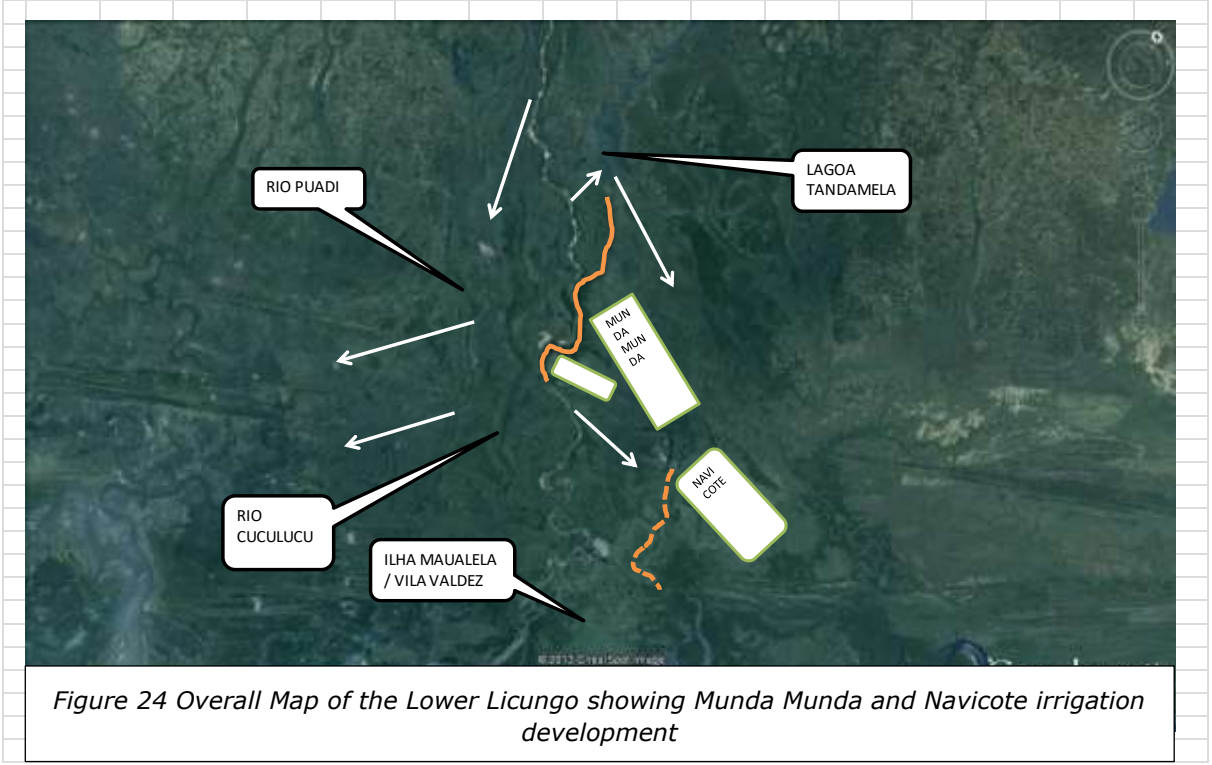
In Figure 24 an overall map of the Lower Licungo is shown. The dike system is projected protecting Munda Munda (and the second block of the Munda Munda project called Navicote) and the Intabo irrigation scheme. The white arrows are showing the flood ways of the river.

A combination of “strong dikes” not to be overtopped and lower dikes which allow overtopping without structural damage by extreme floods are necessary. This necessitates urgent further study to provide a sustainable flood strategy.
